PIANC WORKSHOP

'MITRE GATE DESIGN and OPERATION'

Title: Crack Initiation on stiffeners & repair method, Downstream mitre gate - 4th lock of Lanaye (BE)

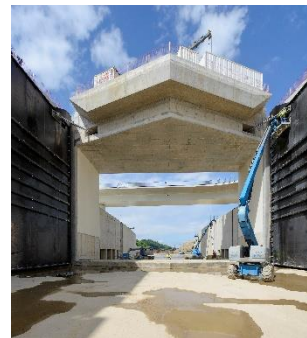
The new class VIb lock of Lanaye (225mx25m) is equipped with a downstream mitre gate. The lock water head is 14 m. The lock was inaugurated in July 2015.

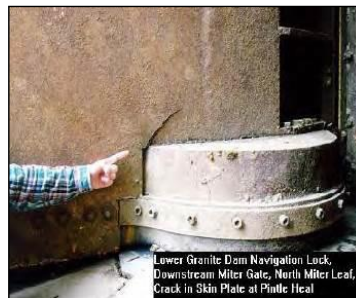
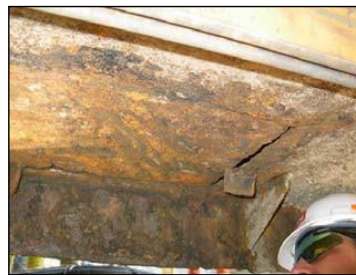
In 1998, cracks were discovered in the skin plates and bottom girders of both gate leaves at the Lower Granite Lock on the Snake River in the state of Washington (See figs on the right). A variety of repair techniques were used to get the gate back into operation.

In 2004, in the McAlpine Lock on the Ohio River cracks were found, which lead to emergency repairs and temporary lock closure. The lock gates were repaired using large patch plates (See Fig bottom left).

In the USA, there has been widespread problems with miter gates cracking near the pintle (bottom pivot) of the gate. The main cause is lack of bearing contact of the gate-to-wall contact blocks. When contact is lost, the large hydrostatic forces acting on the gate are transferred horizontally along the gate through the main framing beams into the pintle (pivot) instead of into the wall bearing area. This causes large localized stresses in the pintle region which when coupled with poor material fracture toughness and poor geometrical detailing leads to cracks.
